## **Truck driver fatally injured after falling into an ore hopper**

**FACE 00-AK-007**

**Release Date: March 30, 2001**

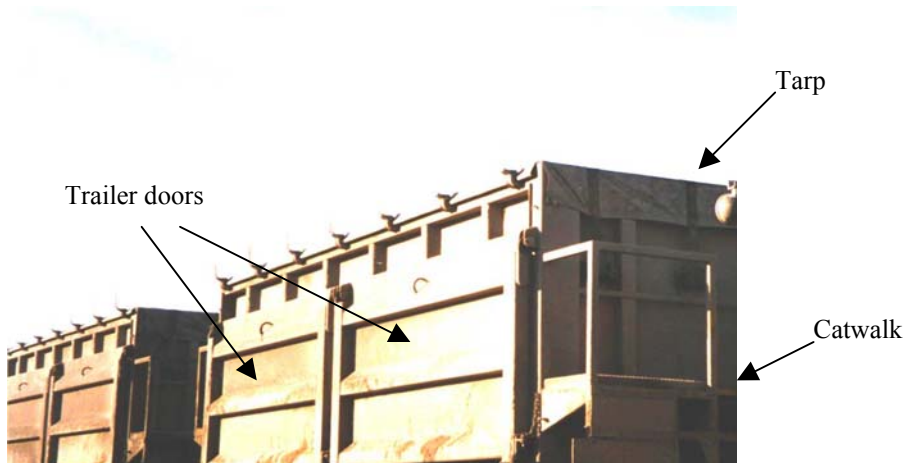
The trailers involved in the incident were two 24-foot side dump trailers, connected in tandem behind a Mack truck with a 40-ton capacity (Figure 1). The overall length of the tractor-trailers was 74 feet. The trailers had 3-foot wide catwalks on either end.

Figure 1. View of trailer and front catwalk

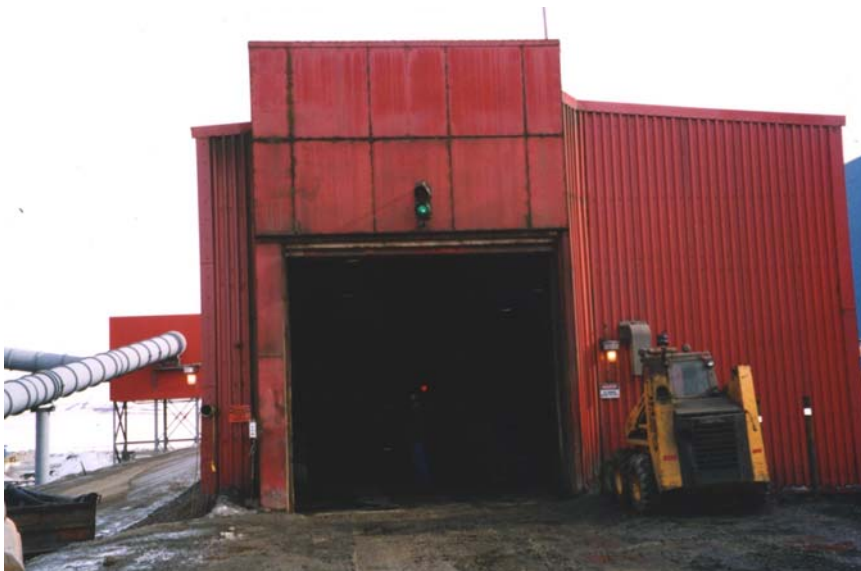
Tractor-trailers were driven into the building and onto the dumping platform located adjacent to the hopper (Figure 2a and 2b).

Figure 2a. Entrance to dump building

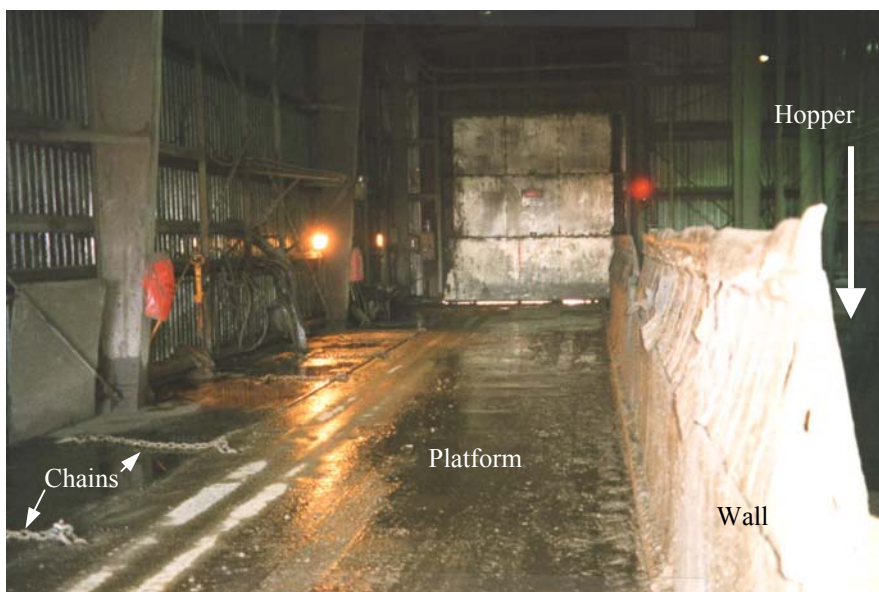
Figure 2b. Dumping platform and wall adjacent to hopper

The platform was 76 feet long and 10 feet wide. Four chains (two per trailer) were used to secure the driver side of the trailers to the platform. A hydraulic lift then raised the driver side of the platform and tipped the tractor-trailers as a single unit to unload ore concentrate through the trailers' side dump doors. A wall, 41 inches tall and 76 feet long, separated the platform from the hopper. The wall was equipped with a lower guard to allow drivers to position the trailers close to the wall without damaging the tires and rims. Two spill aprons (one for each trailer) rotated into position under the trailer doors to help guide the ore concentrate into the hopper. The aprons were positioned with an approximate 4 feet long gap at the center, similar to the gap between the two trailers.

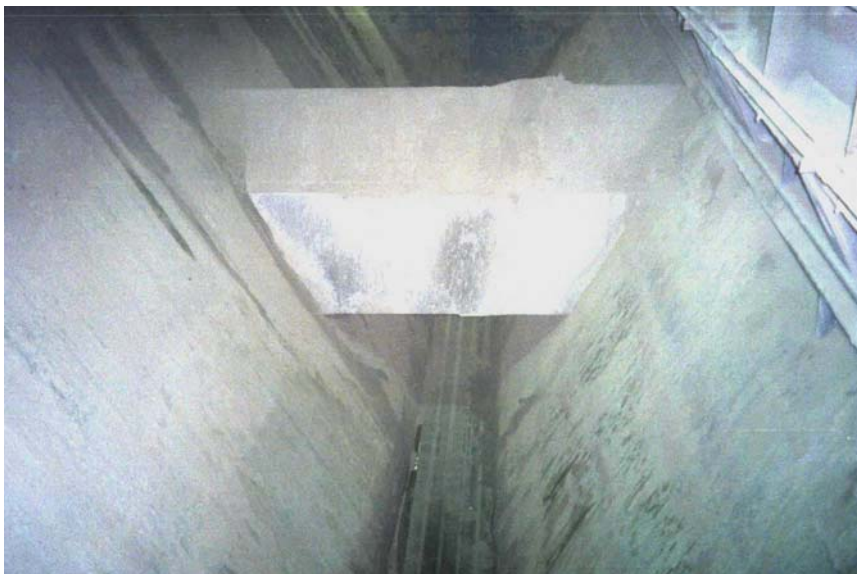
The hopper was 55 feet long and 13 ½ feet deep. It was 14 feet wide at the top and narrowed to a conveyor belt, approximately 3 ½ feet wide, at the bottom (Figure 3). When in operation, the belt moved at a speed of 20 to 35 feet per minute. A permanent ladder inside the hopper near the control room was used to access the bottom of the hopper to break-up large clumps or perform maintenance. Ore concentrate was transferred from the hopper to storage buildings (located on either side of the dump facility) via a series of conveyor belts. Ore concentrate was moved to the end of the hopper where it fell down a shoot to another belt.

Figure 3. Hopper, center divider, and conveyor belt at bottom

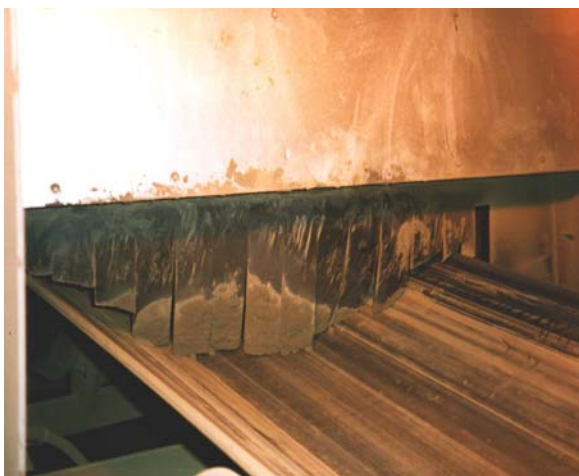
Conveyor belts ran continuously except during maintenance. Each belt moved the ore concentrate to a shoot, where it would drop to the next belt (Figure 4a and 4b).

Figure 4a. Second conveyor belt exiting shoot below hopper

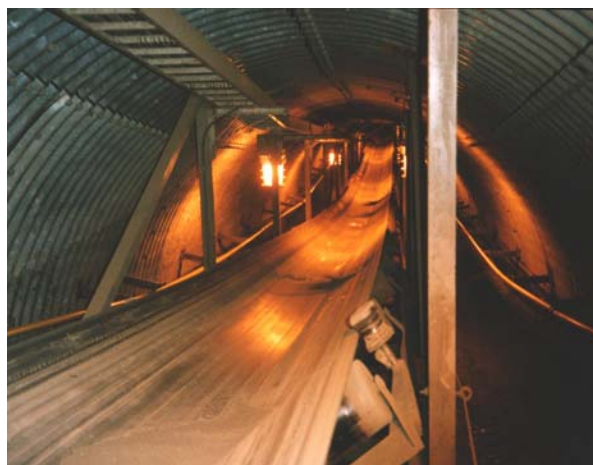
Figure 4b. Second conveyor belt

The second and third conveyor belts were also involved in this incident. The total distance along these belts was 1,016 feet with a maximum belt speed of 204 feet per minute. It was estimated that the time to travel the distance from the beginning of the second belt (below the hopper) to the end of the third belt was approximately 4 ½ minutes. At the beginning of the second belt, a clump sensor automatically stopped all belts if the sensor detected an ore height over 15 inches. Vertical clearance exiting the shoot housing (at the center of this belt) was 15 inches (Figure 4a). At the end of the third belt, a video camera was housed in the top of the shoot; a monitor for this camera was located in the control room. This allowed the operator to observe the ore transfer to a fourth and final belt (to the storage buildings).

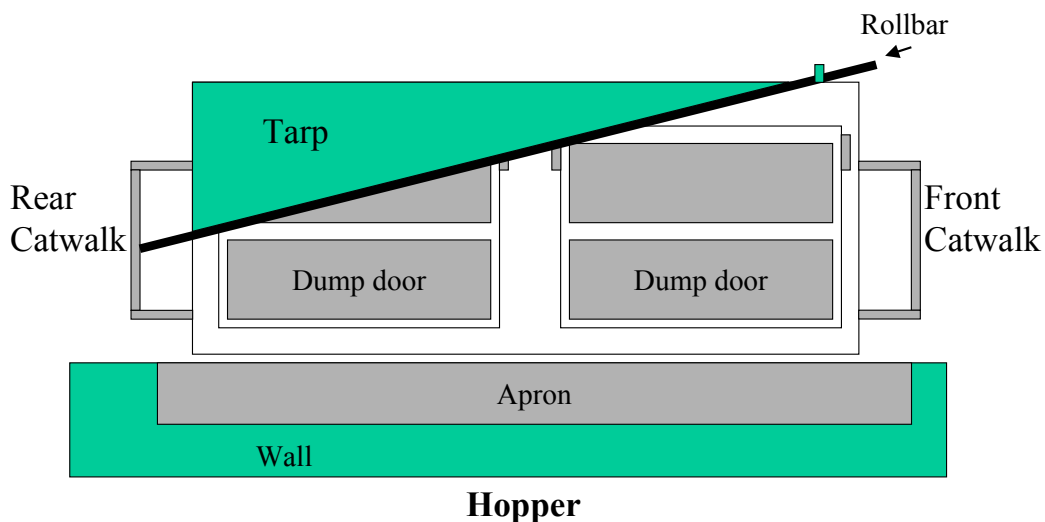
The incident was not witnessed, however two boot prints found on top of the ore concentrate in the front passenger side of the first trailer suggested that the victim had climbed onto the load while parked on the dump platform. Immediately after the incident, the tarp and rollbar was hanging at an angle; the back of the rollbar was about halfway down the back of the trailer

(Figure 5). A portion of the tarp was found on top of the load (passenger side). In addition, a possible boot print was found on the top surface of the wall between the spill aprons. With the restricted area between the driver side of the tractor-trailer and the building wall, it was highly unlikely that the victim walked around the tractor-trailer without being noticed by the operator. Based upon these circumstances, the victim must have fallen into the hopper and then been carried by the first conveyor belt to the end of the hopper. He then fell through the first shoot and was carried by the second conveyor belt. He fell through the shoot at the end of this belt and was carried by the third conveyor belt in the transfer system to the third shoot, where his body became trapped.

Figure 5. Diagram of tarp and rollbar hanging over side of front trailer (not to scale)

The final event that led to the victim falling into the hopper could not be determined. From the top of a trailer, an object will fall to the bottom of the hopper in less than 2 seconds. A fall of this distance can potentially cause incapacitating injuries. The following are possible sequences leading to the incident:

- 1) While standing on the load, the victim lost his balance and fell into the hopper; or
- 2) The victim moved to the end of the first trailer by walking across the tarp on top of the load. He then reached over the side to grasp and pull up the tarp or the rollbar, lost his balance, and fell over the side of the trailer into the hopper; or
- 3) The victim may have climbed outside of the rear catwalk on the first trailer in an attempt to pull up the rollbar. He either lost his grasp or balance and then fell into the hopper.

**Recommendation #1: Employers should require tarps to remain secured to trailers until the trailer is ready to be unloaded.**

*Discussion:* In this incident, the victim followed prescribed work practices that required the tarp to be secured to the trailer while driving to the storage facility. However, it was not an unusual practice for drivers to leave the load covered and loosen or release tiedown straps while waiting to unload. Employers should consider conducting random work site safety inspections and supervisor observations to evaluate compliance with and understanding of established standards and practices and assess possible additions and modifications to standard work practices. In addition, steps for specific practices to be outlined in a safety, health, and environmental program should be discussed with employees to identify routine practices and reasonable actions for unusual occurrences to ensure worker compliance.

**Recommendation #2: Employers should ensure that workers are able to recognize and avoid hazardous situations, such as climbing on loads or anywhere outside a trailer's catwalk.**

*Discussion:* In this incident, the driver positioned himself outside of prescribed safe work areas (trailer catwalks, areas near the hopper with barriers or guardrails) in an extremely hazardous position. The fall protection system on the catwalks at the ends of the trailers had both guard rails and mid rails to prevent workers from falling from these raised platforms. In unusual circumstances, activities outside these areas must be discussed with a supervisor, and a fall protection system agreed upon before beginning a task on an elevated area.
